High-Temperature Corrosion Behavior in Biomass- and Waste-Fired Boilers

Insights into catastrophic corrosion and corrosion mitigation techniques

Julien Phother-Simon

CHALMERS UNIVERSITY OF TECHNOLOGY

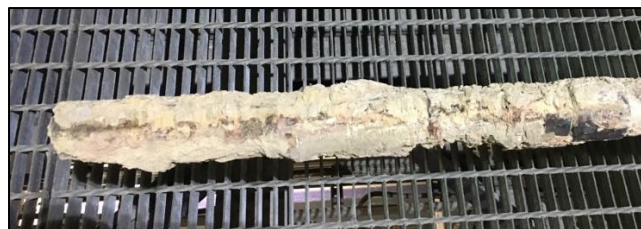
Figure 67: Air-cooled probe exposed 1000 h in the Sulfur Recirculation line (first) and 1000 h in the reference line (after).
